TEST REPORT - EVALUATION
OF DU PONT LRU 488 AS A SEAT
SEAL MATERIAL IN THE MARQUARDT
R4D ENGINE VALVE

TMC Program 7208-3

This work was performed for the Jet Propulsion Laboratory,
California Institute of Technology, sponsored by the
National Aeronautics and Space Administration under
Contract NAS7-100.

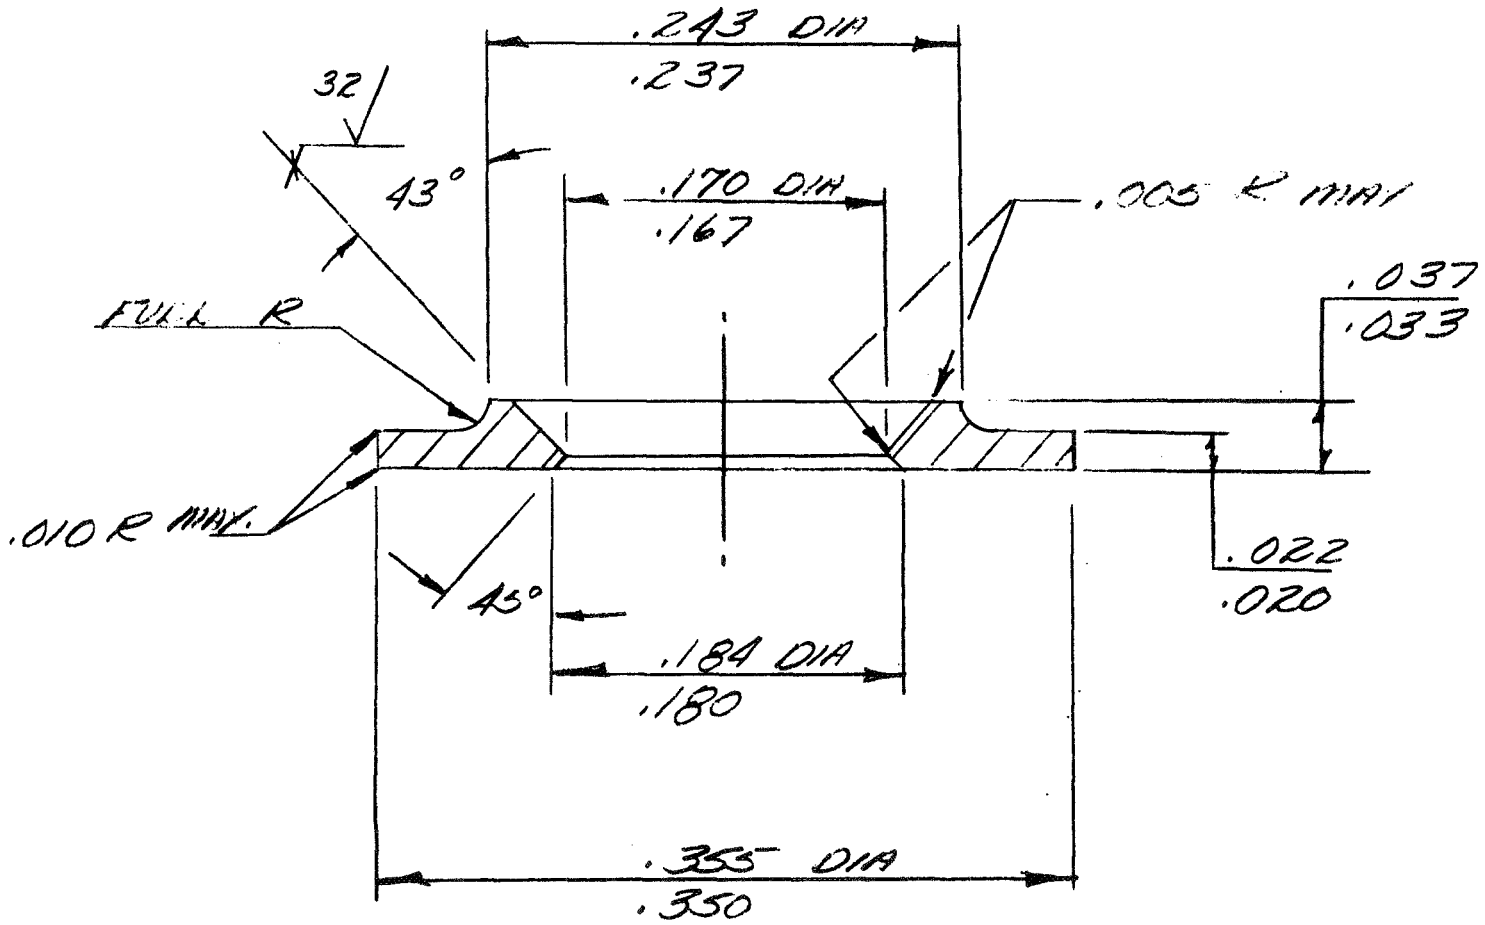
Figure 1

Seat seals of DuPont LRU 488 were molded by JPL in accordance with a TMC-supplied sketch (Figure 1). The configuration of this seal was to provide a seal interface identical with the TFE seal of the Marquardt R4D valve seat assembly (P/N 228683). To substantiate molding accuracy and document critical fit dimensions of the respective seals with the mating parts, seal O.D., I.D. and critical thickness were measured and recorded (Table I). The undersize O.D. dimension indicated material shrinkage which could be compensated for by minor modification of the mold. Seal thickness was slightly oversize but the magnitude appeared to be inconsequential. Under microscopic examination (to 40X) the seal profile was uniform and flash free, with the exception of the outside diameter. A significant quantity of foreign material inclusions were apparent within the seal material (metallic particles and black stringers) but none broke through the surfaces, or appeared to jeopardize the capability of the seal to function.

SEAT SEAL

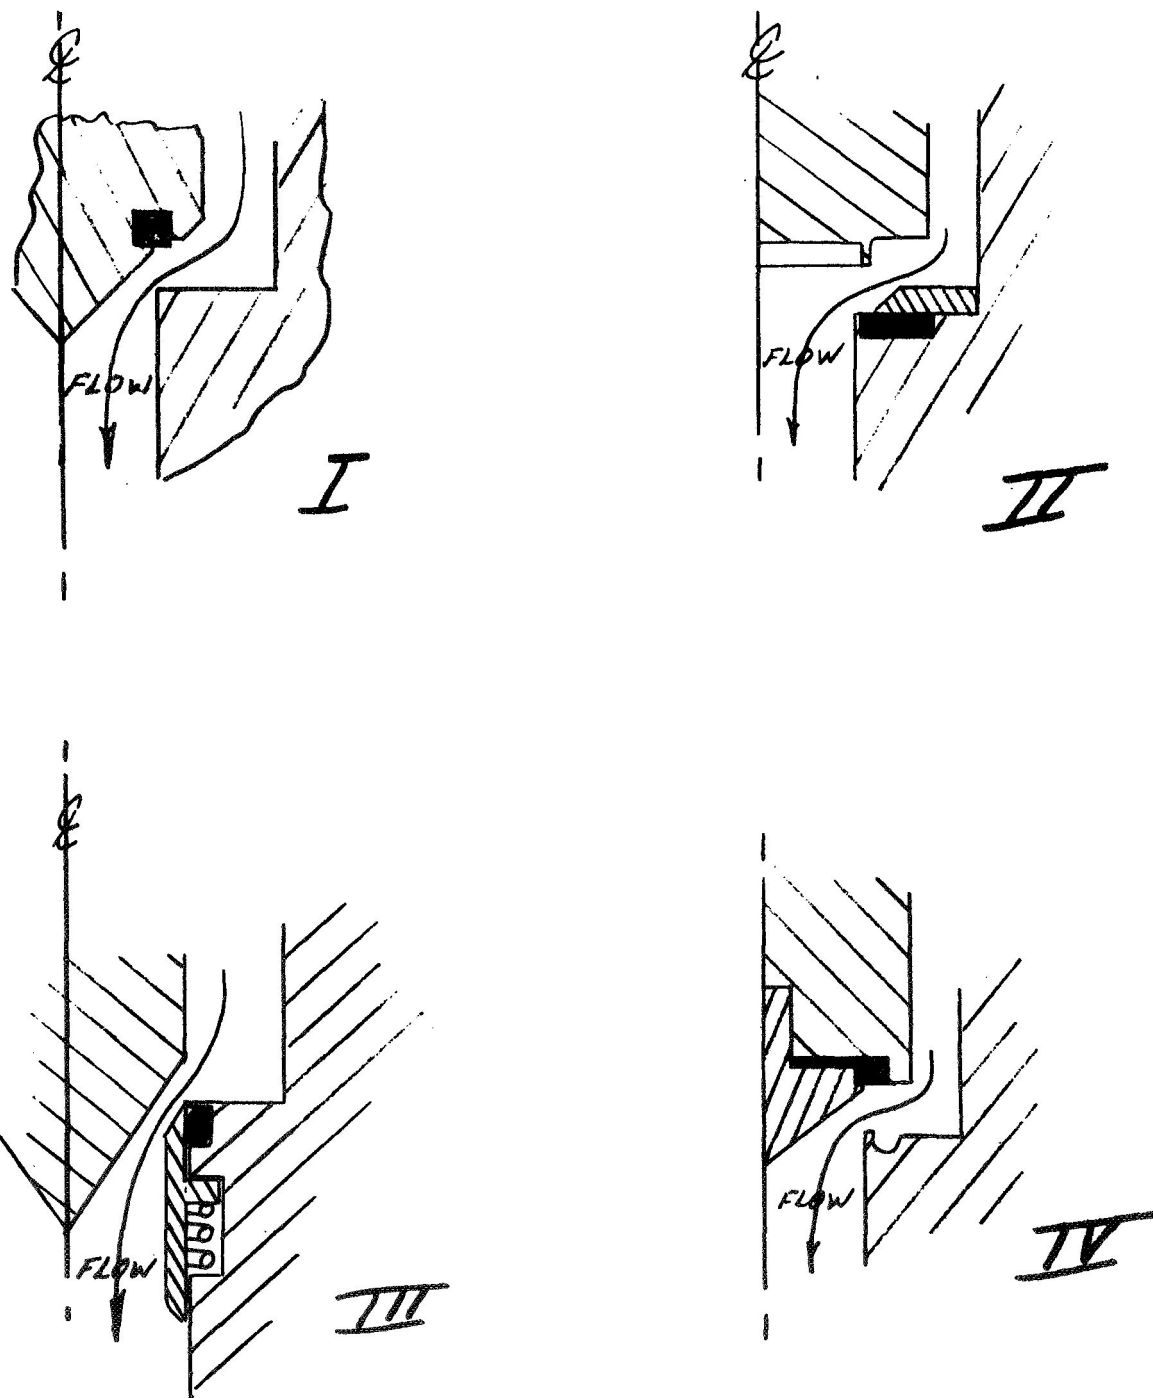
Figure 9

(Figure 9 presents several conceptual designs of seat seals which are consonant with elastomeric seal materials.)

ELASTOMERIC SEAL MATERIAL SEAT DESIGN CONCEPTS

The failure of the test unit seat seal to meet the test goal must be attributed to the seal design, rather than the material, since the flow decay phenomenon observed during initial acceptance testing, is apparently directly related to the ultimate degradation of the seal. Distortion of the seal, due to direct flow stream impingement on the seal, obstructed the normal flow annulus, causing flow decay. During high temperature testing when softening (or weakening) of the seal material occurred, still greater flow decay resulted. During the final valve cycle increment, an attempt was made to compensate for the flow decay by opening the throttling valve downstream of the test unit. The resultant increase in pressure drop across the test unit, in all likelihood, propagated the ultimate seal degradation. The origin of the seal failure, therefore, was the seal design rather than the material. To ensure a LRU 488 seal design of extended life cycle capability, the seal should be protected from flow stream impingement and should be of a design such that minimum structural capabilities are required of the seal material.
